Time Team 2005 Brimham Hall, Hartwith, Harrogate North Yorkshire

Archaeological Evaluation and Assessment of the Results

Brimham Hall, Hartwith, Harrogate, North Yorkshire

Archaeological Evaluation and Assessment of Results

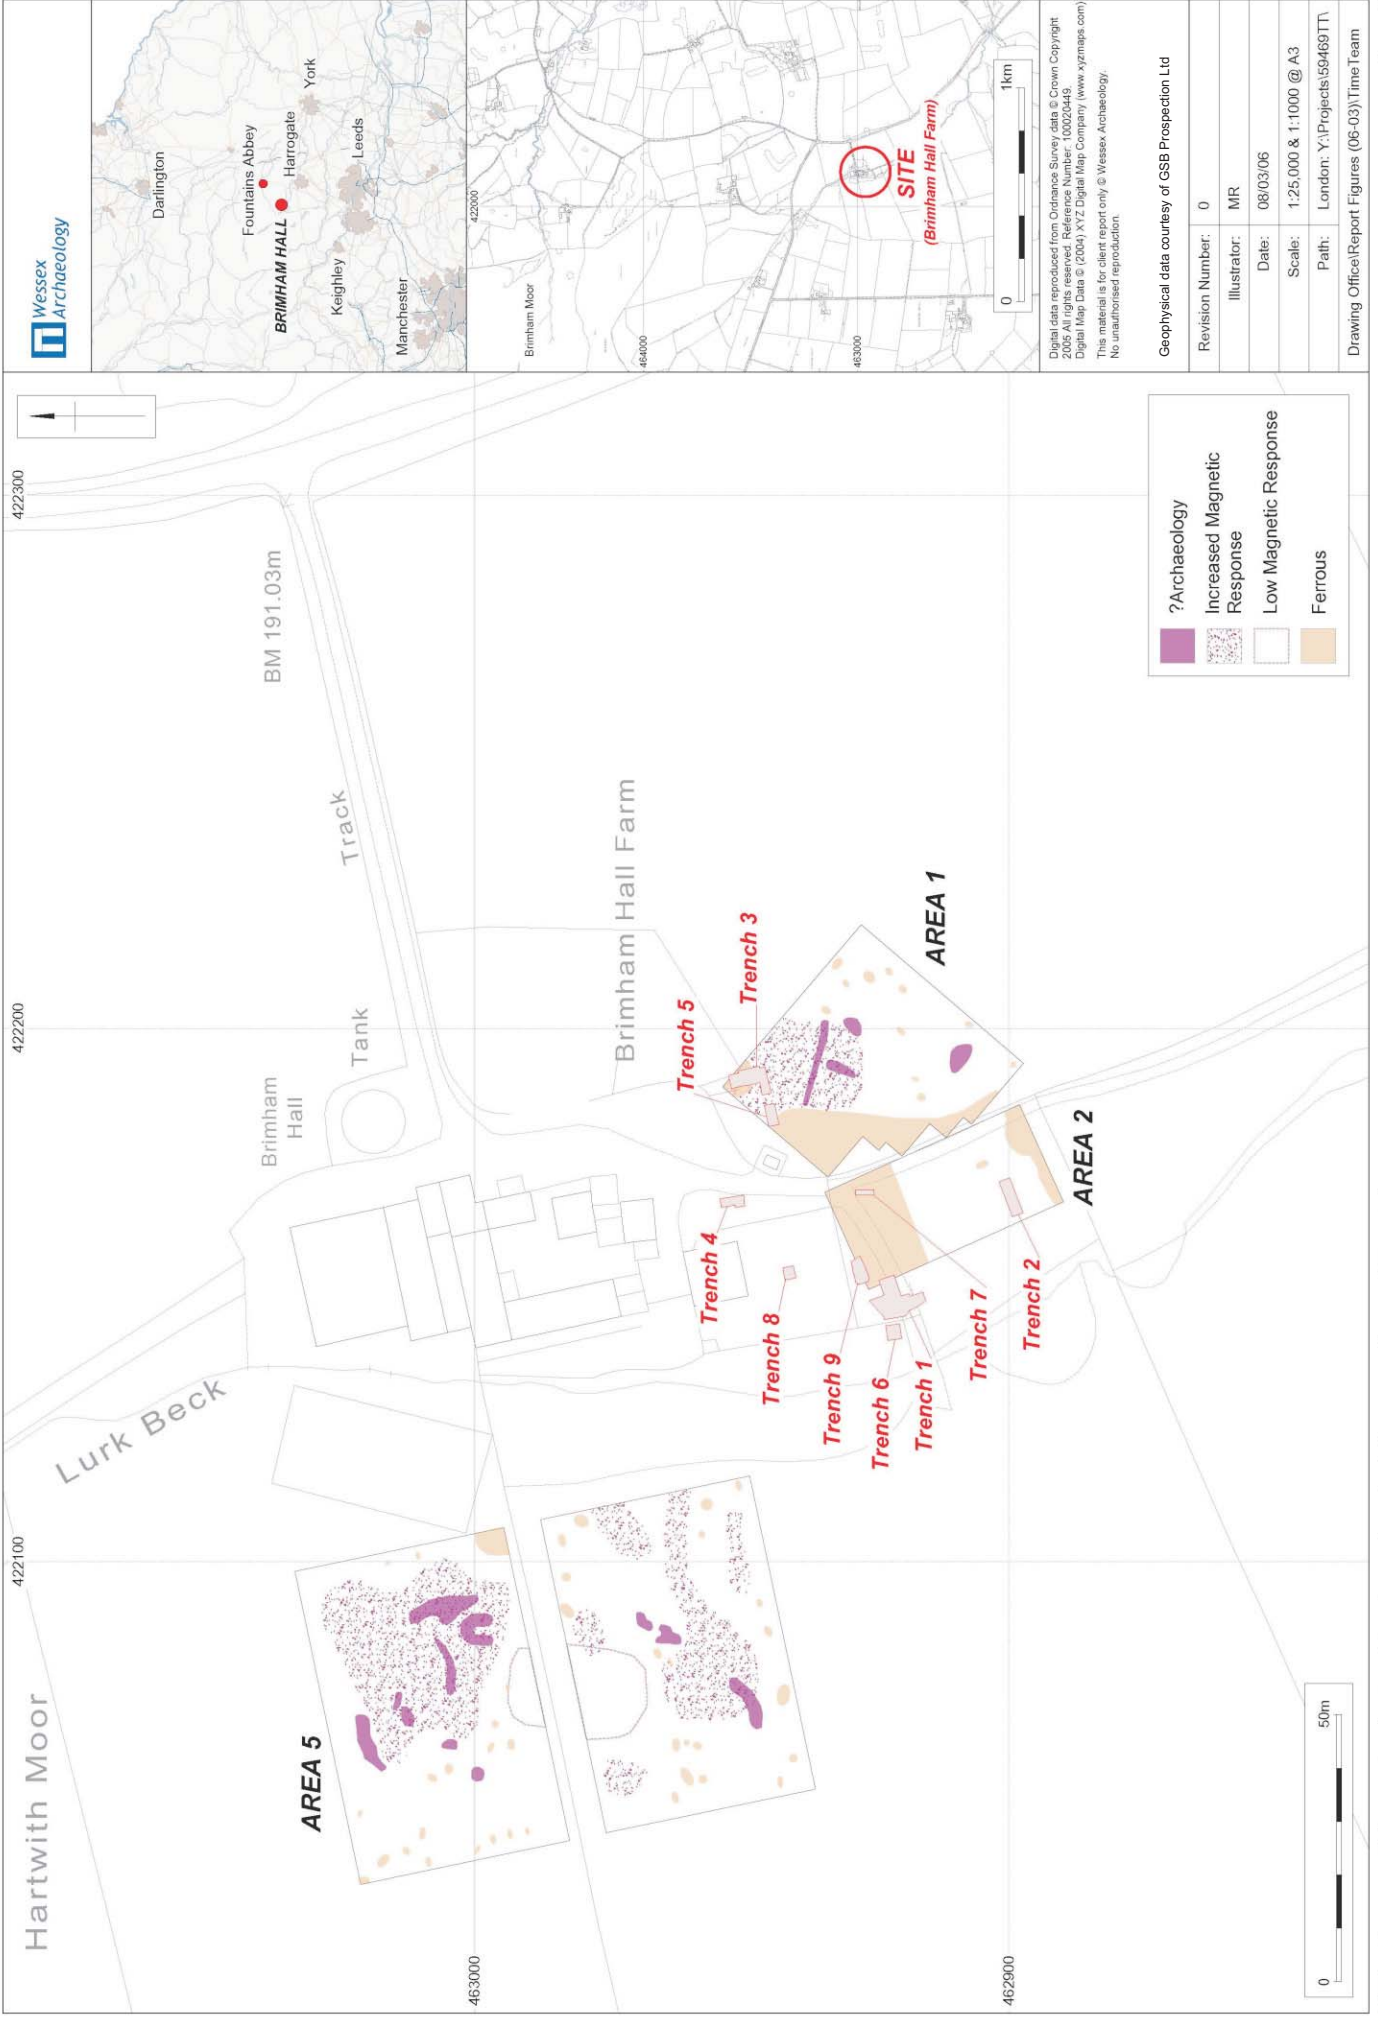
Figure 1

Site location map and site map showing trench locations and geophysical survey gradiometer interpretation

1.1.1 Wessex Archaeology was commissioned by Videotext Communications Ltd to carry out a programme of archaeological recording and post-excavation work on an archaeological evaluation undertaken by Channel 4's 'Time Team' at Brimham Hall, Harrogate, North Yorkshire (**Figure 1**).

- 3.2.2 A total of *c.* 9000m² were subject to geophysical survey (magnetic, resistance and GPR), and in all areas, at least two types of survey were used in an attempt to locate building foundations in greater detail. Generally the resistance data were good, allowing identification and interpretation of suspected archaeological features (**Figure 1**, Areas 1, 2 and 5). Where there is a strong electromagnetic contrast, the GPR signal can be inter-reflected or reverberated, producing a delay in the reflection of the signal. As a result, it is often not possible to detect the base of features; only the tops of buried features/deposits are detected with certainty.

- 3.2.3 The resistance survey recorded several anomalies of archaeological interest in areas adjacent to the farm buildings, suggesting substantial wall foundations with clearly defined edges. Excavation over these anomalies

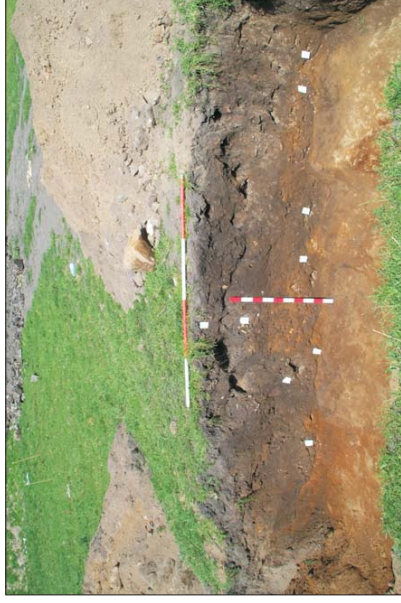
Plate 6: Trench 2, south east facing section (Scale = 1m & 0.5m)

- 3.3.13 Wall 204 was placed in construction cut 203. However, this cut was much wider and deeper than wall 204, and may represent the foundation for an earlier wall that had been robbed out. Wall 204 reused an existing wall foundation trench after it had partially silted up. Cut 203 was 1.3m wide and 0.9m deep and was sealed by topsoil. It was steep and straight-sided on its south-western side and stepped on its north-eastern side (**Figure 3 section**), implying it had been modified on the north-east side by robbing. Large quantities of fragmented millstone grit rubble were retrieved from a deposit (202) roughly contemporary with the robber cut and may represent debris from the demolition and robbing of this earlier wall.

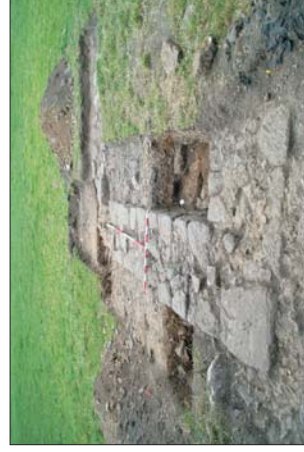
Plate 7: Post-excavation view of Trench 3 showing building (Structure 318) from north (Scale = 1m & 0.5m)

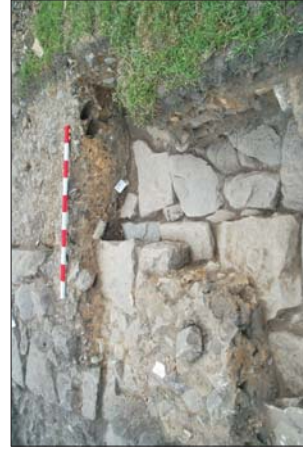
Plate 8: Trench 3, detail of paving 316 from south (Scale = 1m)

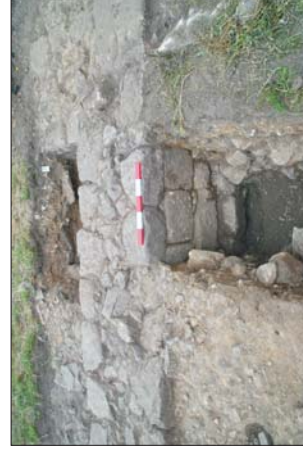
Plate 9: Trench 3, detail of Wall 302 and footing 315 from east (Scale = 0.5m)

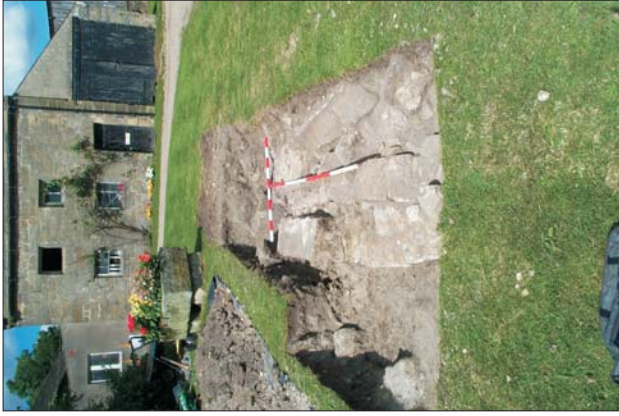
Plate 10: Post-excavation view of Trench 4 from south (Scales = 1m & 2m)

3.3.24 This was a hand-excavated trench (measuring 4.7m by 2m), and was opened over a geophysical anomaly that suggested the presence of a building adjacent to the path that leads to the present farmhouse. The archaeology within this trench had been disturbed to some extent by a modern electricity cable running along its western side. Within the backfill of this cable trench (402) a large number of broken decorated tiles were retrieved, presumably relating to disturbance of a floor of an earlier structure (**Plate 11**). All these redeposited tiles are of the same design as those from the tiled floor in Trench 1, and are of 15th/16th century date (see **Section 4.3** below). Immediately below the topsoil, a stone rubble layer was encountered (404), which contained large rectangular blocks of millstone grit masonry. This horizon included frequent flecks of lime mortar, and it probably relates to the collapse of an earlier wall (**Plate 10**).

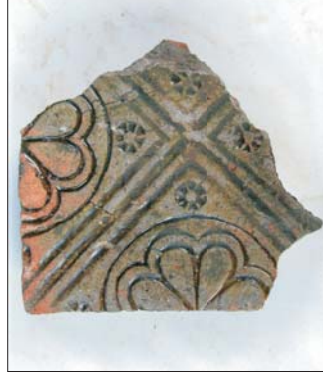
Plate 11: Decorated tile fragment from Trench 4 (Context 402)

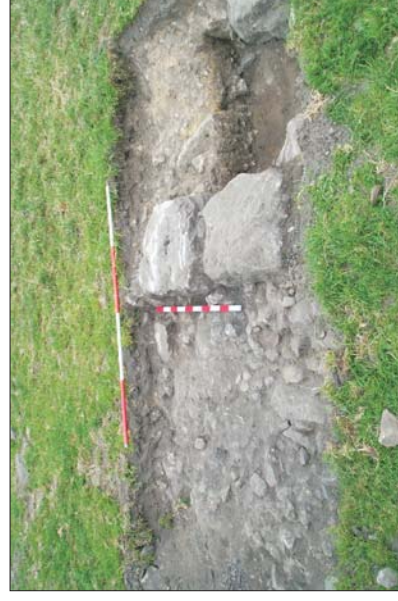
Plate 12: Post-excavation view of Trench 5 from south (Scales = 1m & 2m)

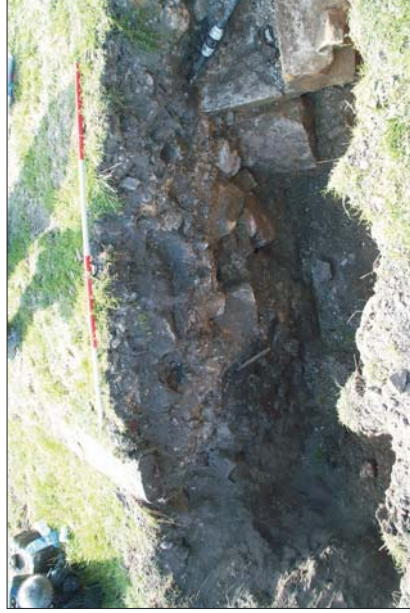
Plate 13: Post-excavation view of Trench 7 from east (Scales = 2m)

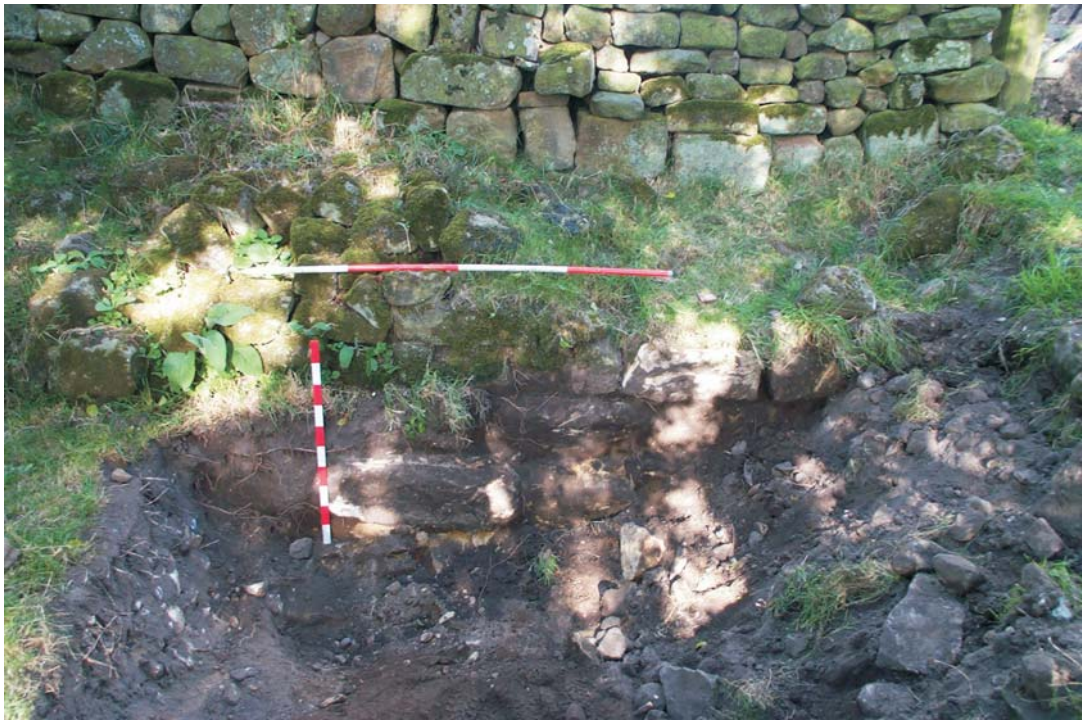
Plate 14: View of Trench 6 showing wall 604 from west (Scales = 1m & 2m)

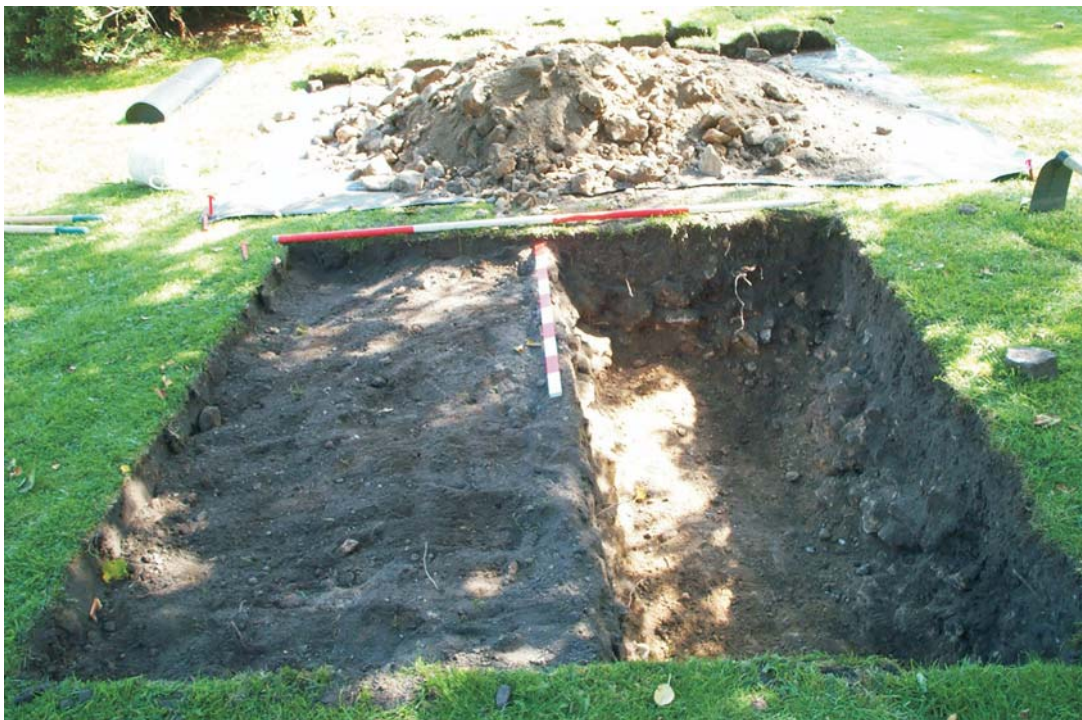
Plate 15: Post-excavation view of Trench 8 from north (Scales = 1m & 2m)

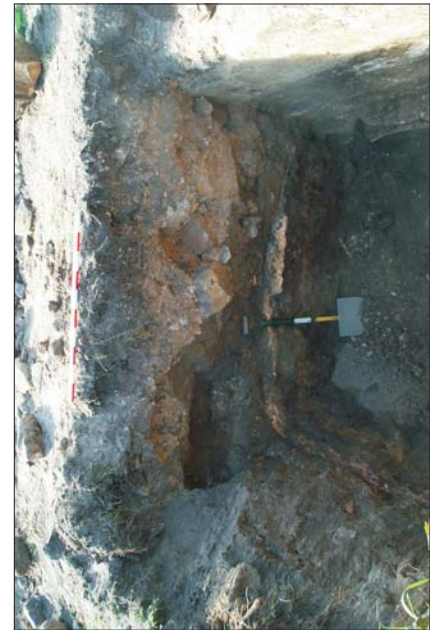
Plate 16: View of Trench 9 from north (Scale = 1m)

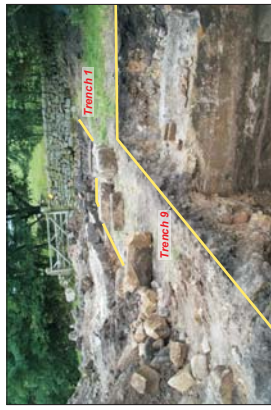
Plate 17: View showing relationship of Trenches 1 & 9 from north east

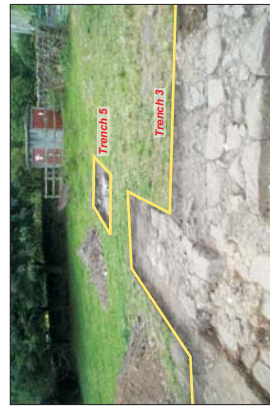
Plate 18: View showing relationship of Trenches 3 & 5 from north east
